# AURIX™ TC29x errata sheet

**Marking/Step: ES-BC, BC**

## About this document

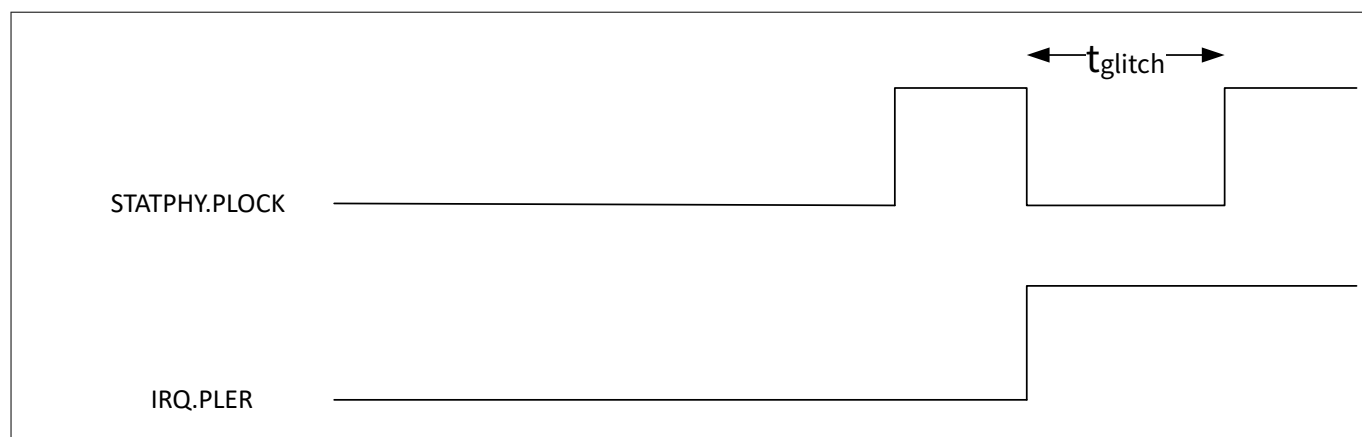
**Figure 4 PLL Unlock Event Glitch**

After STATPHY.PLOCK shows lock status, there is a possibility that the PLL is unlocked once for a short time ( $t_{\text{glitch}}$ ) again at start-up phase, as shown in the figure below. This single unlock event as indicated by STATPHY.PLOCK recovers back to lock status without any software intervention.

The minimum time duration of  $t_{\text{glitch}}$  is 224 cycles of the PLL reference clock (RefClk). An example of minimum  $t_{\text{glitch}}$  duration for RefClk with 20 MHz and 10 MHz is shown in the table below.

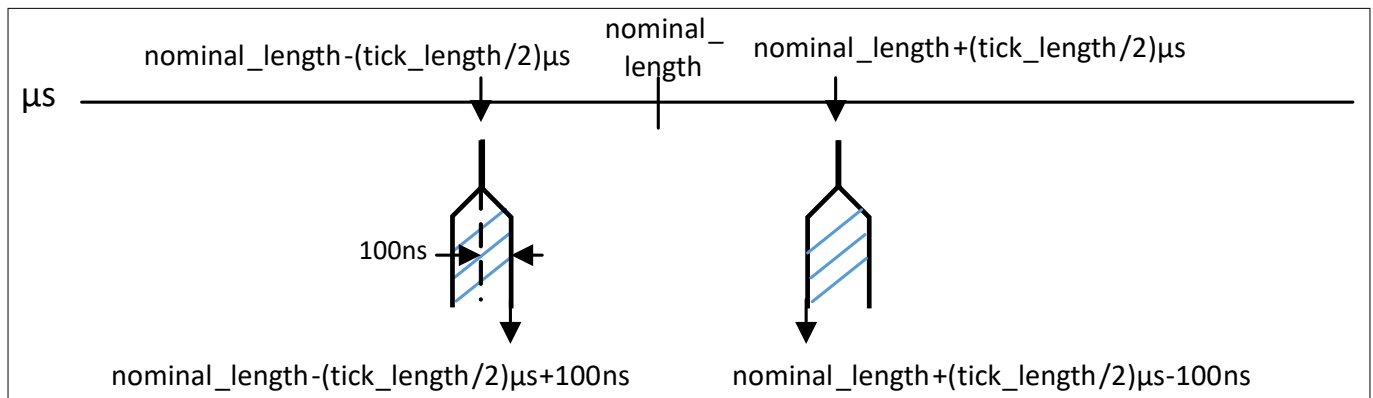
- The lower border is  $\text{nominal\_value} - (\text{tick\_length}/2) \mu\text{s} + 100 \text{ ns}$
- The upper border is  $\text{nominal\_value} + (\text{tick\_length}/2) \mu\text{s} - 100 \text{ ns}$

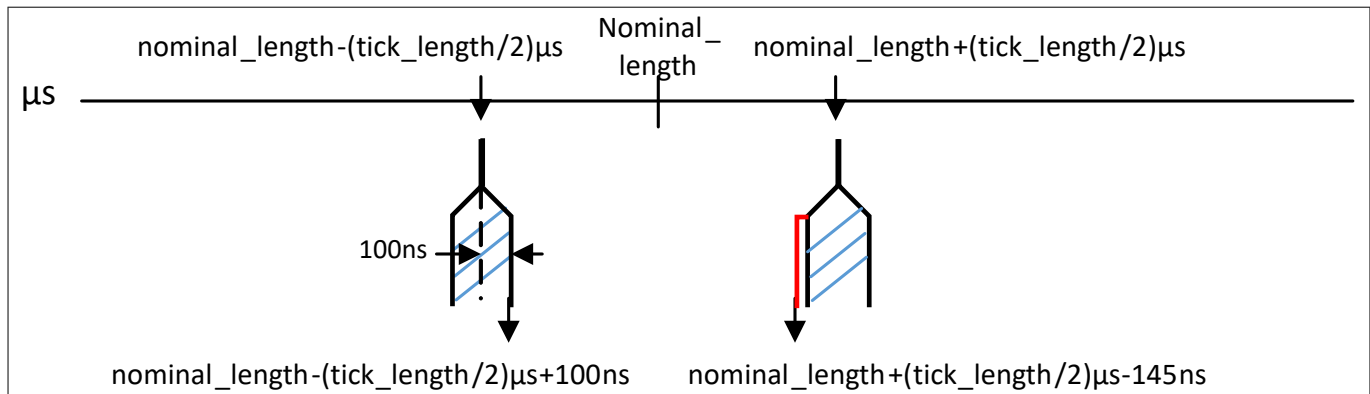
**Figure 15** SENT Tolerance of this Design Step

- The lower border is  $\text{nominal\_value} - (\text{tick\_length}/2) \mu\text{s} + 100 \text{ ns}$
- The upper border is  $\text{nominal\_value} + (\text{tick\_length}/2) \mu\text{s} - 145 \text{ ns}$
