# AURIX™ TC29x errata sheet

**Marking/Step: ES-BC, BC**

## About this document

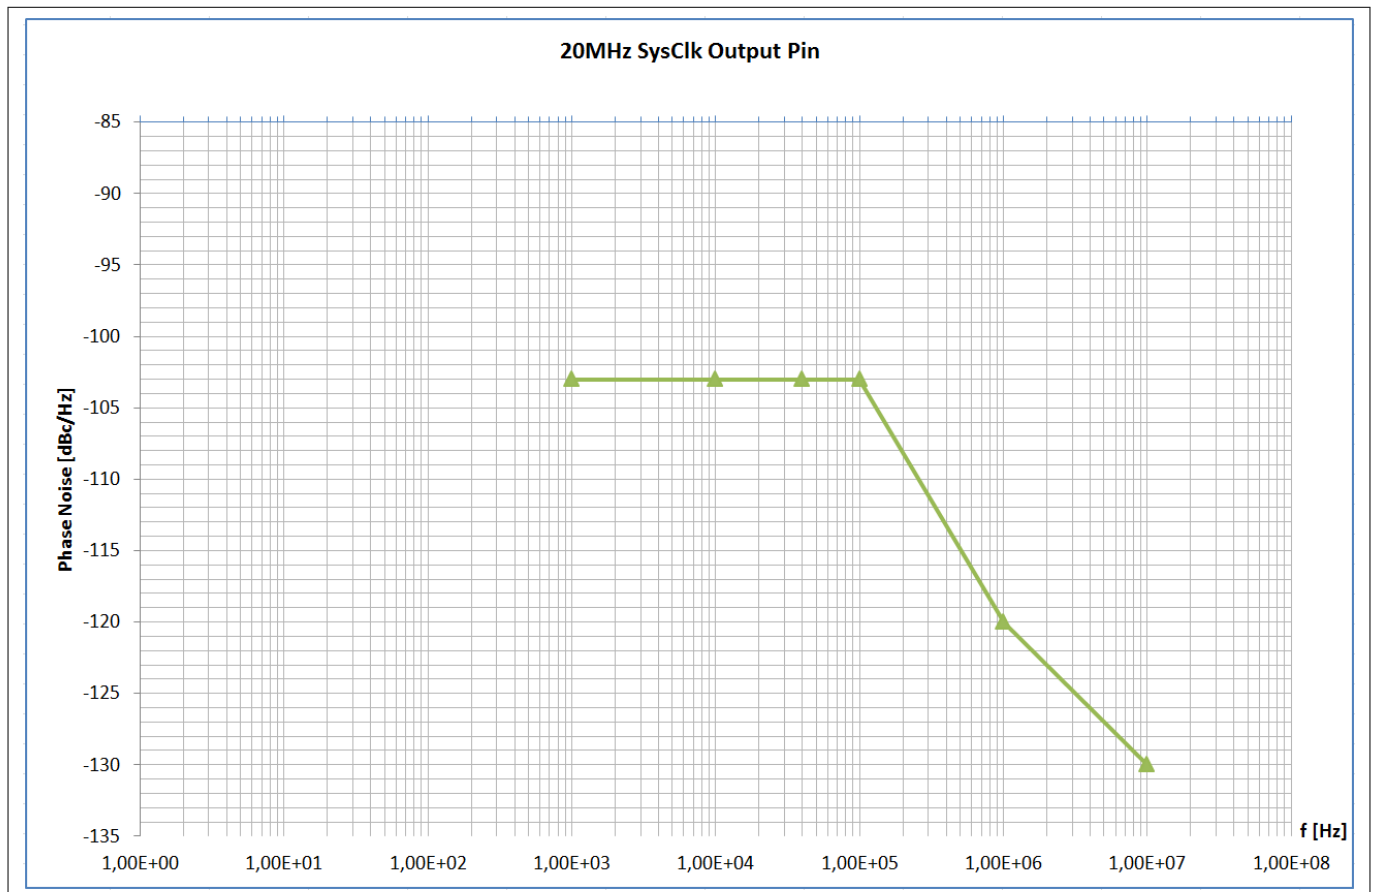
**Figure 6** Phase Noise Density on SysClk Output Pin

Nevertheless, such a target value on the random jitter of the SysClk signal is only an intermediate specification. The real target to be respected in order to assure  $BER_{20}$  of  $10^{-12}$  is the total jitter of the link. The total jitter target is met. Consistently, measurements on the HSSL/HSCT communication channel using the SysClk signal with  $I_{PN}$  from above show that the ultimate target of  $BER_{20} = 10^{-12}$  is met. In such a measurement setup, both the master and the slave are microcontrollers of the AURIX™ family.

The diagram below shows the phase noise density on the SysClk pin when no application pattern but only the HSSL/HSCT subsystem is running:

When designing the PLL for an HSSL/HSCT ASIC, the values for  $I_{PN}$  and  $J_{ABS20}$  above and ultimately  $BER_{20} = 10^{-12}$  can be achieved with the following recommendations:

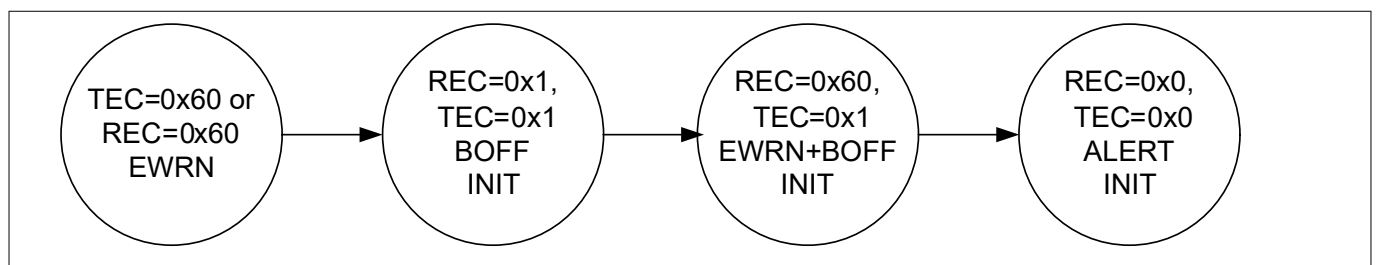
**Figure 9 Alert Interrupt Behavior in case of Bus-Off**

The MultiCAN module shows the following behavior in case of a bus-off status:

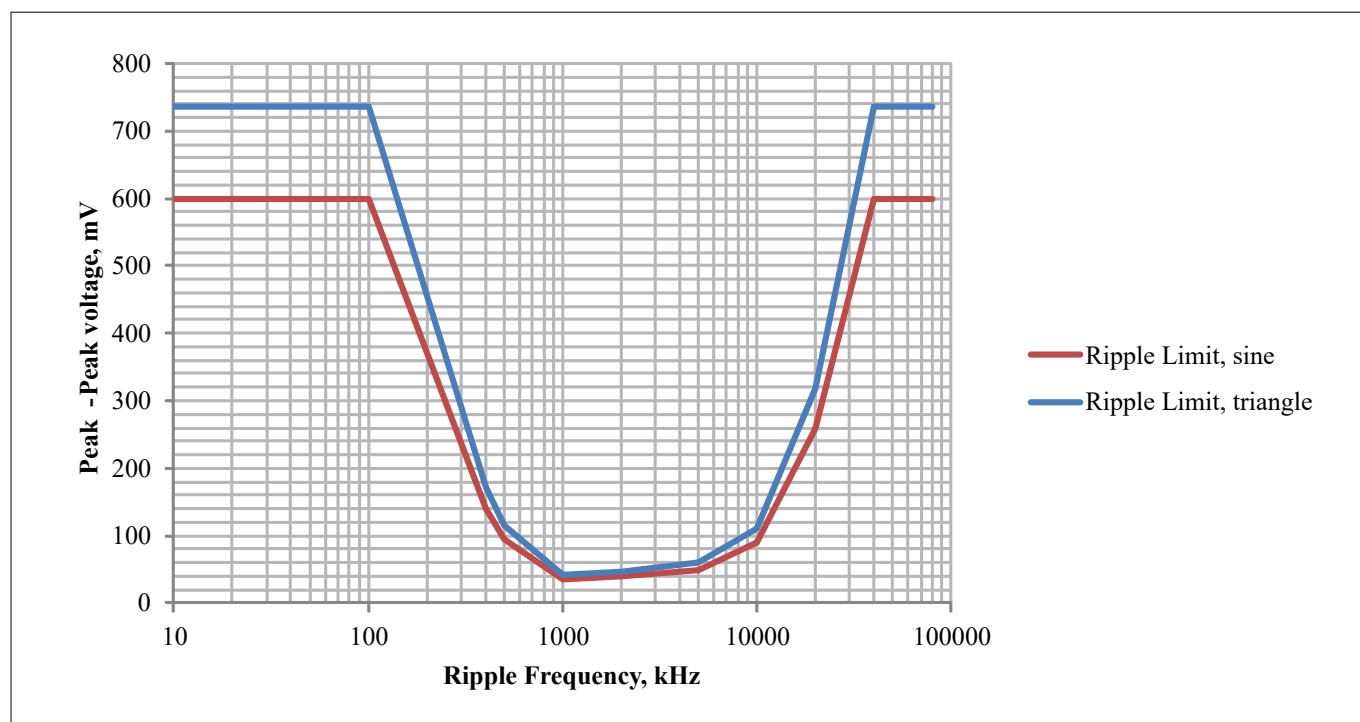
**Figure 13** Ripple Voltage vs. Frequency Characteristic

The acceptable voltage vs. frequency characteristic is portrayed below on the chart:

The diagram reflects acceptable ripple level during the cold start of the microcontroller at the respective VDDP3/VEXT/VEVR SB supply of the PMS subsystem, depending on the device and package type, as shown in the following table.

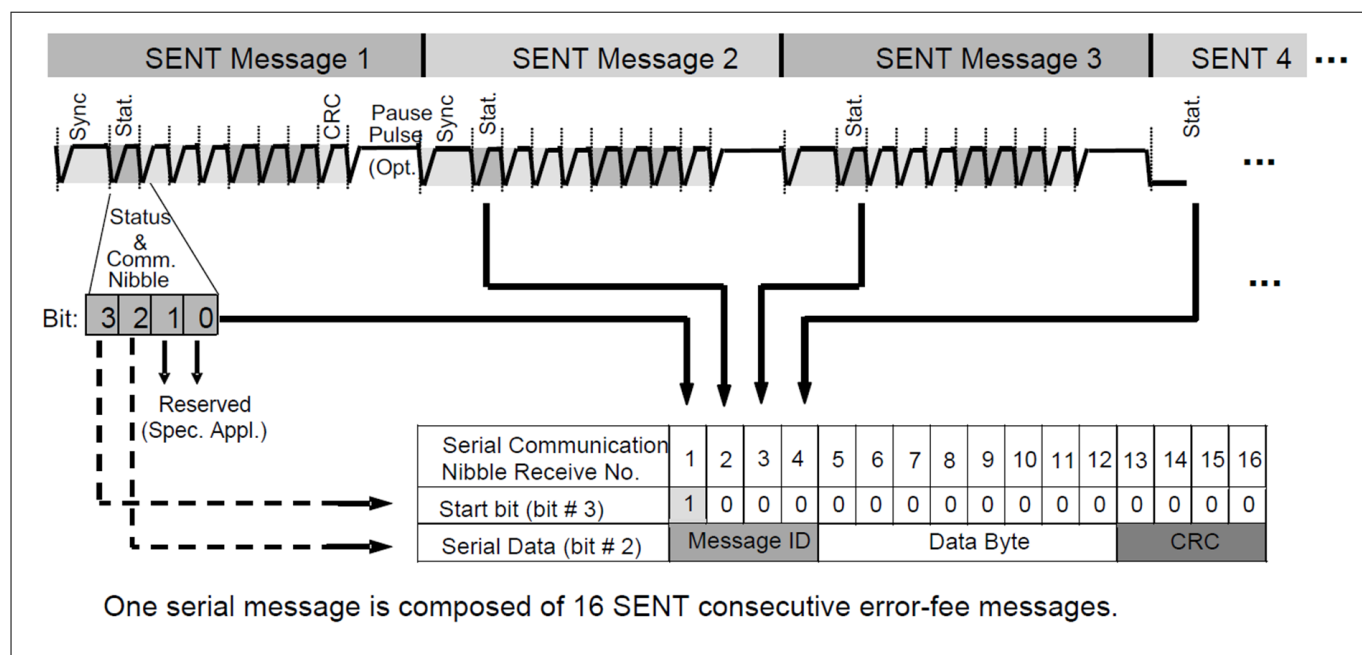
**Figure 16** Short Serial Message, Serial Data Encoding over 16 messages

Figure 16 shows a corrected version of this figure.
